Case Report

Misplacement of Temporary Pacing Wire into the Left Ventricle Via an Anomalous Vein

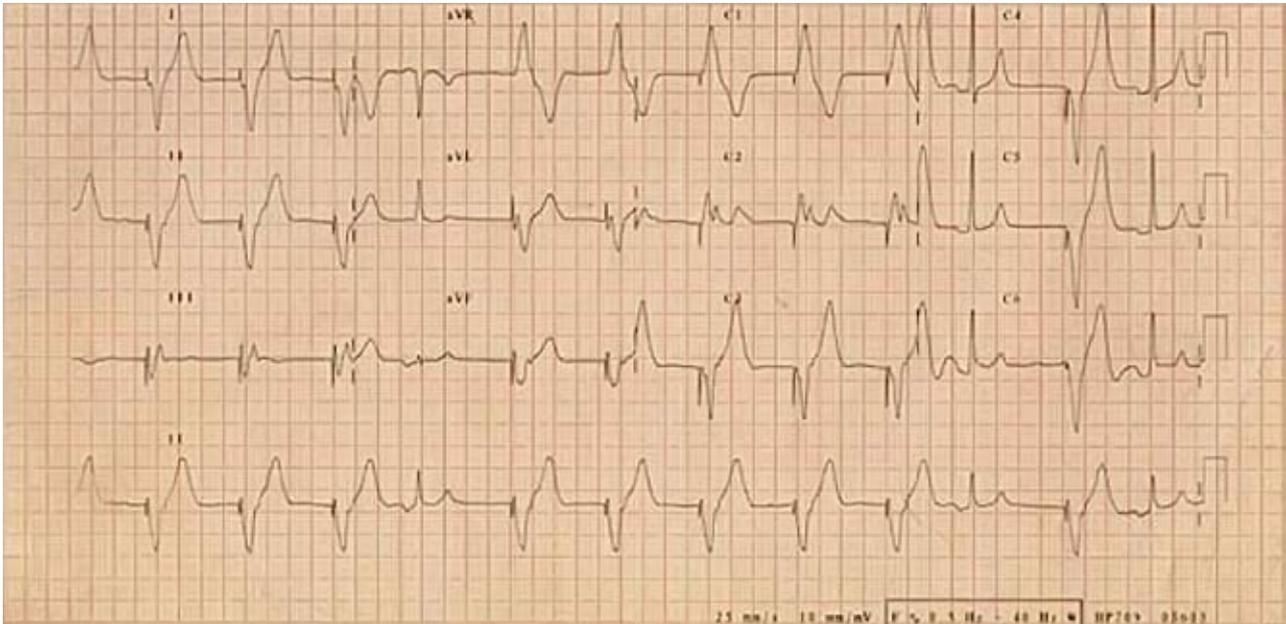
Figure 1. Electrocardiogram demonstrating right bundle branch block pattern during pacing.

A 74-year-old lady was brought into casualty with syncope. A 12-lead electrocardiogram (ECG) demonstrated complete atrioventricular block with a ventricular escape rate of 37 beats per minute. As the patient was haemodynamically unstable, a temporary pacing wire was inserted via the left internal jugular vein. Ventricular capture was achieved with difficulty and threshold for capture was measured at 4 volts. The ECG during pacing showed a right bundle branch block (RBBB) pattern

On the 12-lead ECG, the presence of an RBBB pattern usually signifies left ventricular pacing – although occasionally this pattern may also be seen if the pacing lead is in the right ventricle.⁵ Features on the electrocardiogram that can help correctly identify RBBB due to right ventricular pacing and differentiate it from left ventricular pacing include left superior axis deviation (frontal axis between -30 and -90 degrees), the presence of RS or qR morphology in lead V_1 and

precordial transition in lead V_3 .⁵ RBBB seen in right ventricular pacing can also sometimes be made to disappear if the precordial leads V_1 and V_2 are placed one interspace lower than the standard location.⁶

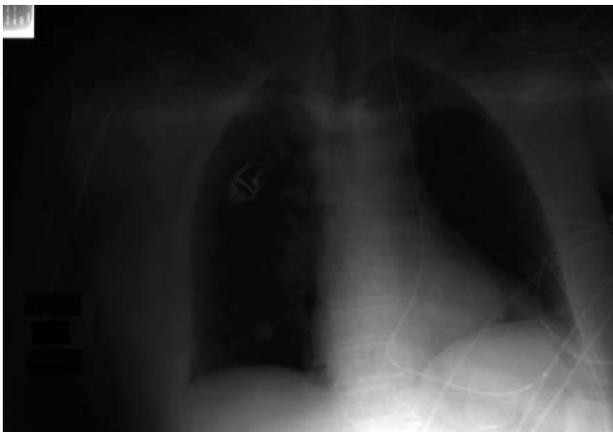
Figure 2. Chest radiograph demonstrating the left vertical paramedian course of the pacing wire.

(Figure 1) and a chest radiograph showed the pacing wire to follow a left paramedial position prior to entering the heart (Figure 2). The pacing wire was removed and a computed tomogram (CT) of the chest with contrast was performed to check for a suspected venous anomaly. On the CT scan, the left subclavian vein was seen to bifurcate as it entered the chest. The larger anterior division crossed over the midline and joined with the contralateral brachiocephalic vein to form the superior *vena cava*. The posterior smaller division was seen to unite with probably the left superior intercostal vein to form a common trunk. This common trunk was seen to descend inferiorly along the lateral aspect of the aortic arch, left main pulmonary artery and enter the left atrium (Figure 3). It is most likely that the pacing wire had passed down this vessel into the left atrium and crossed through the mitral valve into the left ventricle.

The 12-lead ECG and chest X-ray post procedure can provide valuable clues that help in the recognition of lead misplacement. On frontal chest X-ray, a normally positioned pacing wire should follow a right vertical paramedian course, signifying passage through a normal right-sided superior *vena cava* before entering the right heart. A left vertical paramedian position indicates placement into a left internal thoracic vein, persistent left-sided superior *vena cava* or left superior intercostal vein.⁴ A lateral chest radiograph can help distinguish between these possibili-

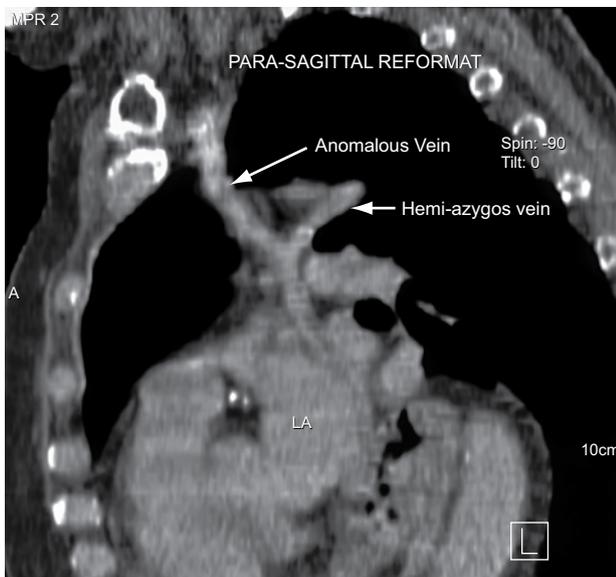
Figure 3. Parasagittal reformat of computed tomographic scan demonstrating the anomalous vein feeding into the left atrium.

an anomalous vessel connecting the left subclavian vein to the left atrium.
