Cardiac Imaging

Three-Dimensional Echocardiography for Transcatheter Mitral Valve Paravalvular Leak Closure

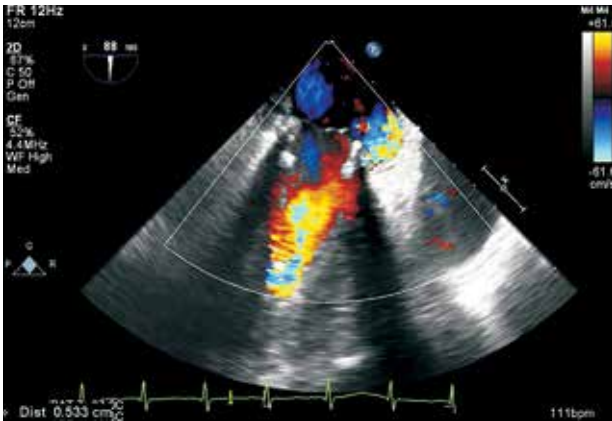
Figure 1. Preoperative two-dimensional color flow transesophageal echocardiogram, showing severe mitral paravalvular leak (PVL; jet width measured around 0.5 cm).

Preprocedural catheterization findings included severely elevated left atrial pressure, as witnessed by a mean atrial pressure of 25 mmHg. Preprocedural echocardiography findings (Figures 1 & 2) included severe mitral regurgitation due to PVL (PVL jet width measured 0.53 cm).

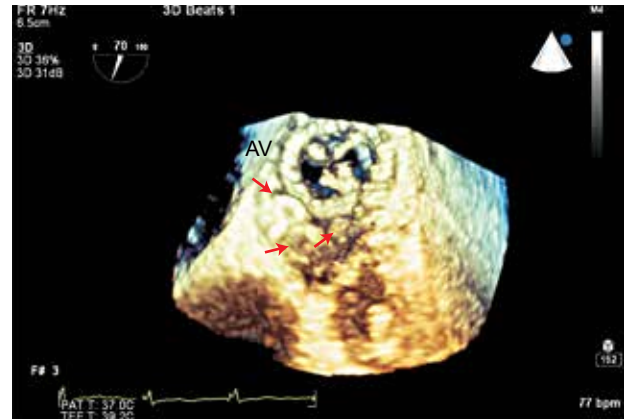
Figure 3. Three-dimensional transesophageal echocardiogram post operation, showing the successful emplacement of three Amplatzer plugs (arrows).

Postprocedural findings included a decreased mean left atrial pressure of 12 mmHg and no signs of PVL on the echocardiogram, on either two- or three-dimensional images or color flow images (Figures 3-5).

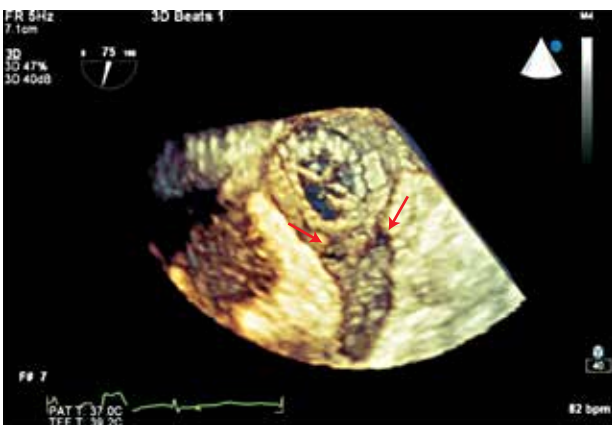
Figure 2. Three-dimensional transesophageal echocardiogram pre operation, showing the mitral paravalvular leak spots (arrows).

The leak appeared to be anterolateral and was oriented in the general direction of the left atrial appendage (LAA). It was seen in direct communication with the LAA from 50° to approximately 120°. No thrombus was seen in the LAA or the left atrial cavity. Successful PVL closure was performed under the guidance of 3-D TEE, using three Amplatzer plugs in total. A 10 mm vascular plug #2, a 10 mm vascular plug #2, and a 6 mm vascular plug #2 were used. Three-D TEE offers additive value in the placement of the Amplatzer devices, since stereotactic guidance is needed.¹⁻⁵

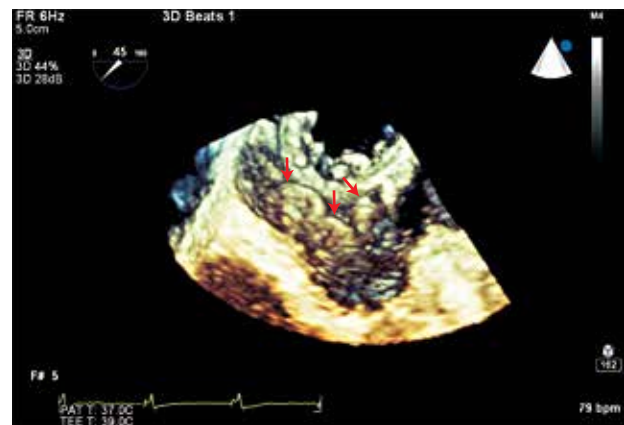
Figure 4. Three-dimensional transesophageal echocardiography image of mitral paravalvular leak closure, zooming on the three Amplatzer plugs (arrows).

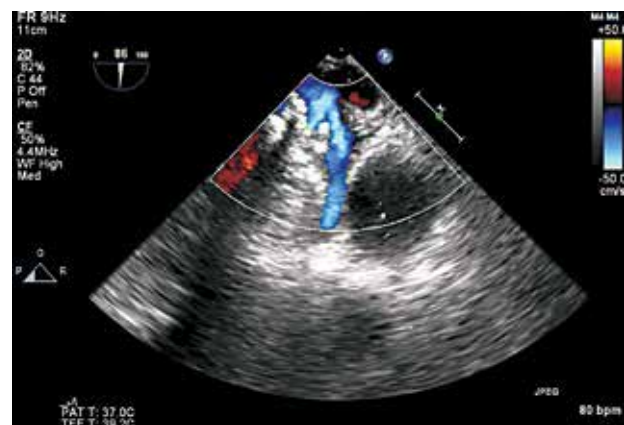
Figure 5. Two-dimensional color-flow transesophageal echocardiogram, showing the absence of paravalvular leak after the procedure.
