Cardiac Imaging

Successful Transapical Transcatheter Prosthetic Mitral Paravalvular Leak Closure

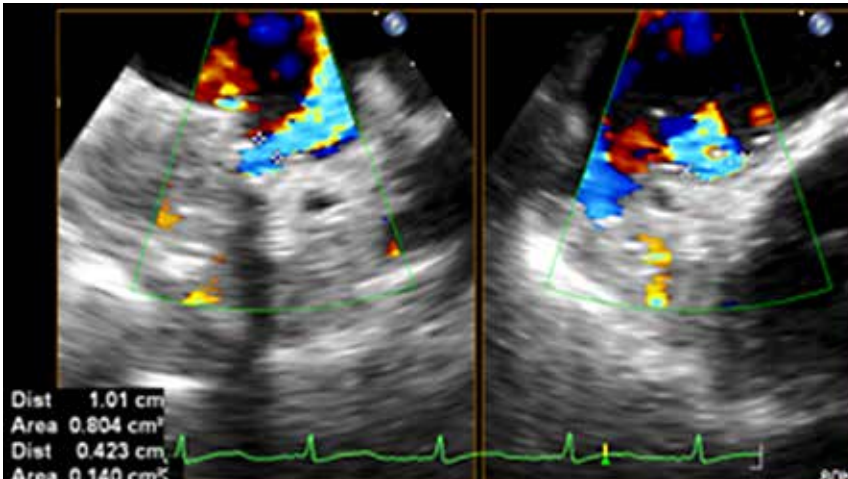
Figure 1. Preoperative two-dimensional transesophageal echocardiography (TEE), color biplane imaging: a moderate oval shaped paravalvular leak (PVL), 1.01 × 0.42 cm in size, was detected.

A 71-year-old female was admitted to our department with severe dyspnea (NYHA class III) and hemolytic anemia (hemoglobin level 7.0 g/dL, lactate dehydrogenase 1500 IU/L). She had a history of metallic aortic valve replacement 16 years before for aortic stenosis, metallic mitral valve replacement 3 months before for mitral stenosis, and a permanent pacemaker implantation 1 week before for tachy-brady syndrome. Transesophageal echocardiography (TEE) showed a severe mitral paravalvular leak through a crescent-shaped hole that was located in the anterolateral portion of the mitral valve prosthesis. (Figures 1 & 2). Active endocarditis was excluded.

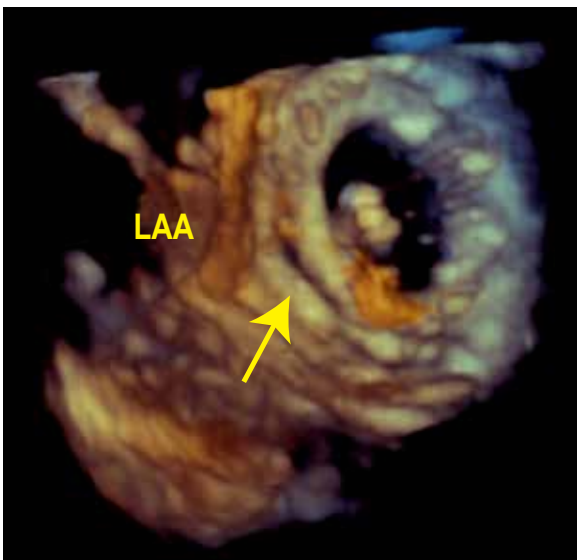
Figure 2. Preoperative real-time 3D TEE, atrial view, showing the PVL (arrow) at the 9 o'clock position, slightly distant from the prosthetic cuff. LAA – left atrial appendage.

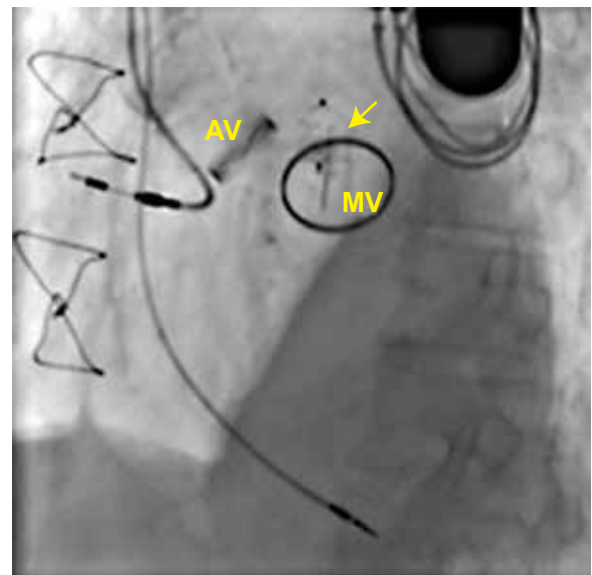
Figure 3. Fluoroscopy demonstrating the Vascular Amplatzer plug (arrow) deployed. AV – aortic valve; MV – mitral valve.

TEE and fluoroscopic guidance. Following a left anterior mini-thoracotomy the defect was catheterized using a Terumo wire loaded on a multipurpose 5F catheter. After the positioning of the catheter inside the left atrium (LA), the Terumo wire was replaced by an Amplatzer stiff wire, which supported the insertion of a multipurpose 7F guide catheter to the LA. Through the guide catheter, a 10 mm × 5 mm Vascular Amplatzer plug III (AGA Medical Corporation, Plymouth, MN) was successfully deployed under 2D and 3D TEE and fluoroscopic imaging (Figure 3). Good valve function was confirmed immediately post deployment. TEE showed an appropriate position of the device and no residual leak. (Figures 4 & 5).

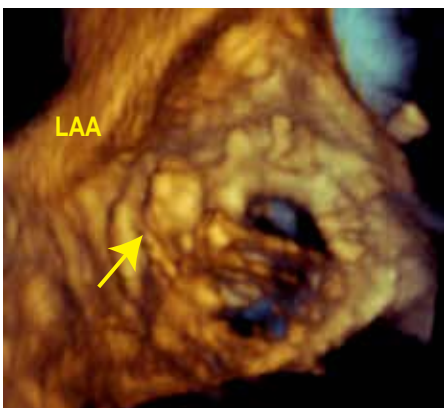
Figure 4. Postoperative real-time 3D TEE, atrial view, showing the Vascular Amplatzer plug (arrow). LAA – left atrial appendage.

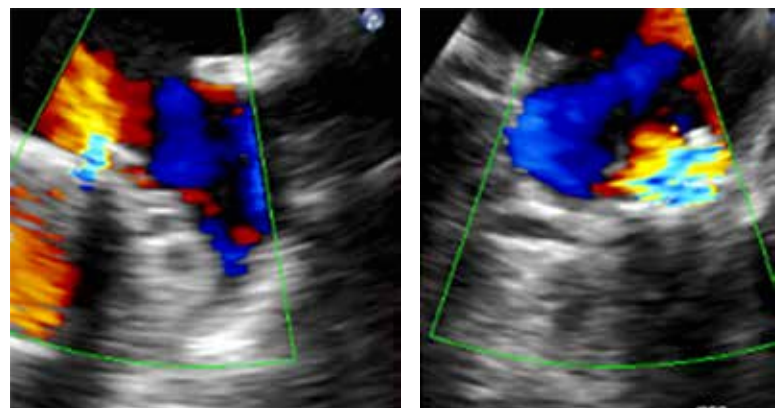
Figure 5. Postoperative 2D TEE after placement of the Vascular Amplatzer plug, showing complete occlusion of the PVL. Mild foaming through the device was also noted.
